Home Inspection Report

PROFESSIONAL HOME INSPECTION

Anywhere Road , Nashville , TN 37216

Friday, June 29, 2018

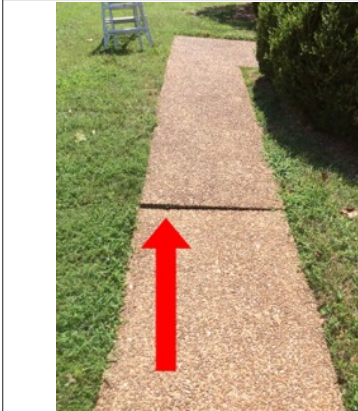
Some settlement can be seen in the front sidewalk. Repair/level the sidewalk to help prevent tripping.

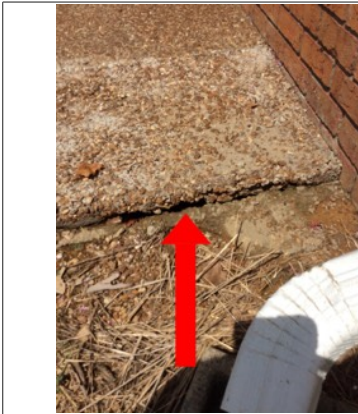
A void can be seen under the patio. Recommend having the void filled to prevent settlement.

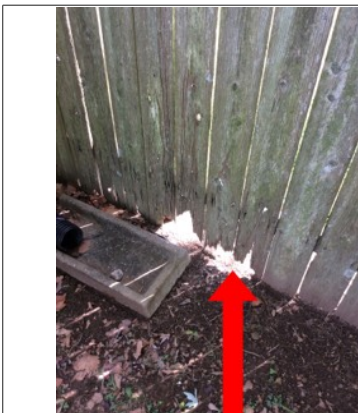
Multiple areas of deterioration were found in the wood fence. Repair or replace the fence.

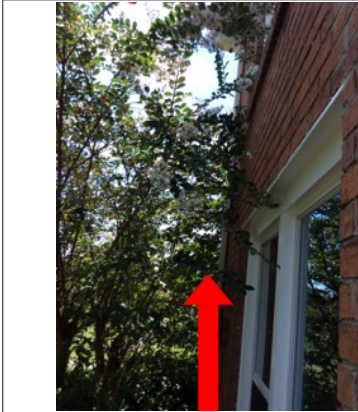
Recommend trimming the tree branches and bushes so they are not in contact with the house.

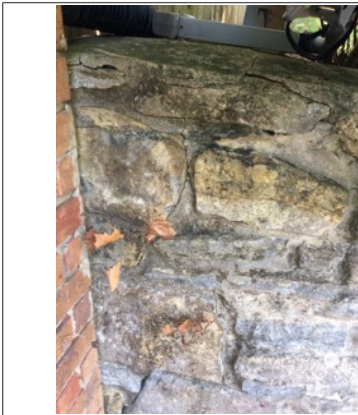
A few small cracks were seen in the retaining wall. The wall is in overall good condition.

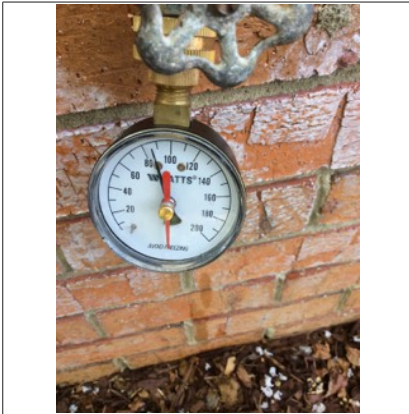
The water pressure at the hose bib is approximately 85 PSI.

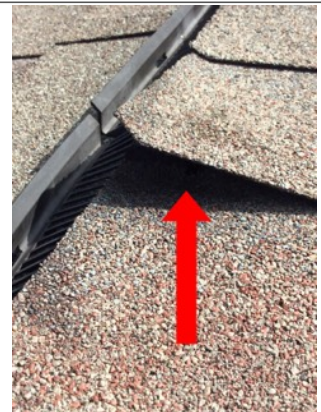
A nail pop was seen on the ridge of the roof. Repair to prevent leaking.

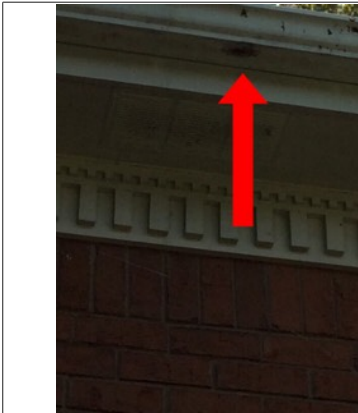
Rust and some holes were seen in the gutter on the front side of the house above the garage. Repair or replace the affected gutters.

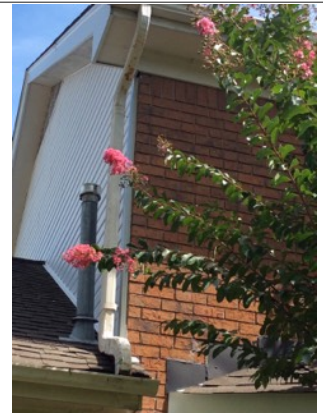
Rusted gutters

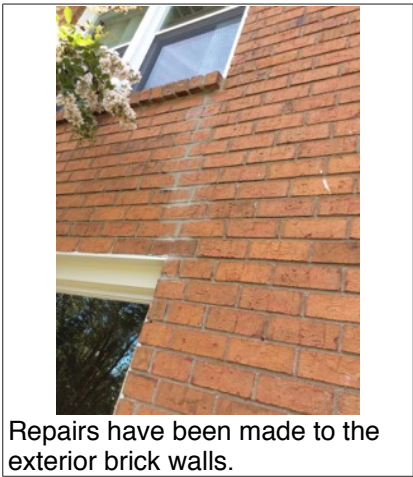
Repairs have been made to the exterior brick walls.

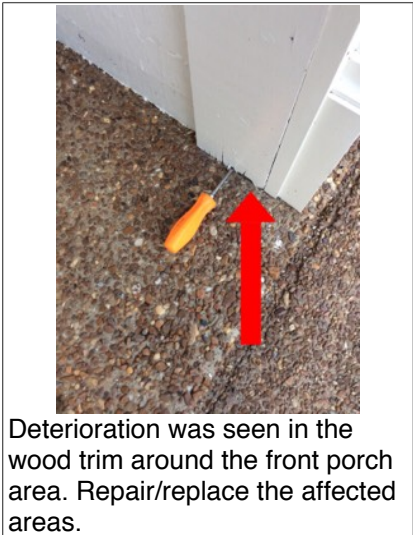
Deterioration was seen in the wood trim around the front porch area. Repair/replace the affected areas.

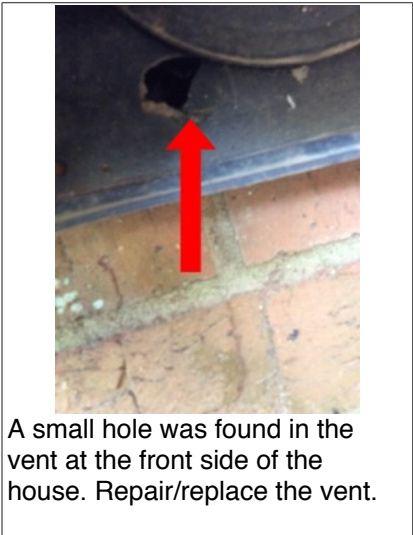
A small hole was found in the vent at the front side of the house. Repair/replace the vent.

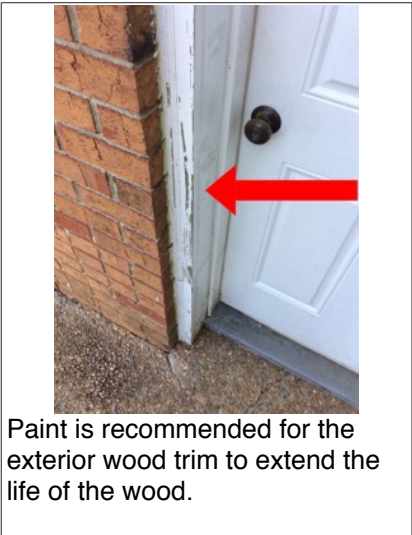
Paint is recommended for the exterior wood trim to extend the life of the wood.

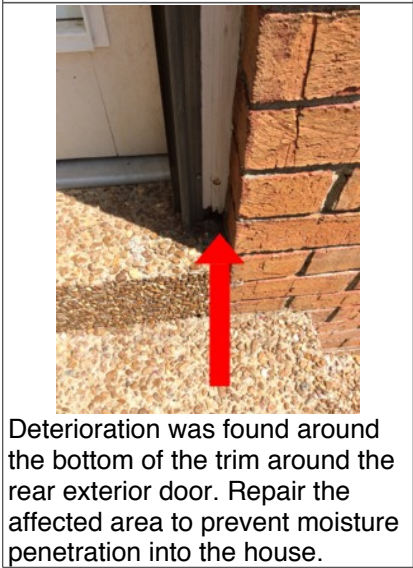
Deterioration was found around the bottom of the trim around the rear exterior door. Repair the affected area to prevent moisture penetration into the house.

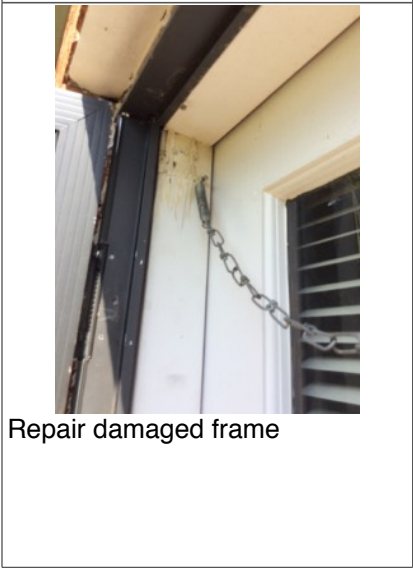
Repair damaged frame

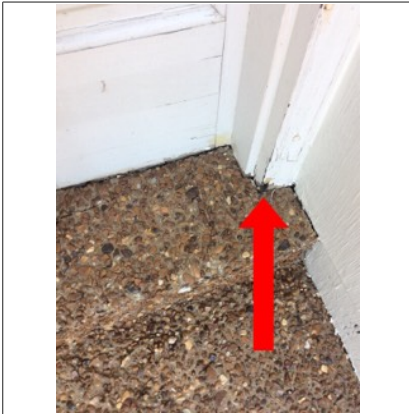
Caulking is recommended for the area between the front porch floor and the house to ensure a weathertight seal.

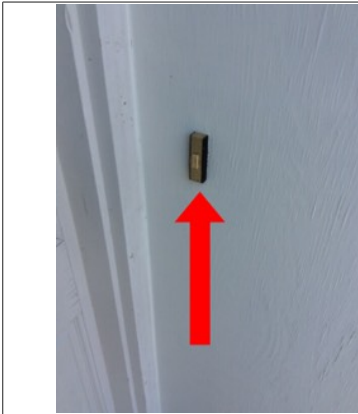
The doorbell is not working properly. Repair or replace the doorbell.

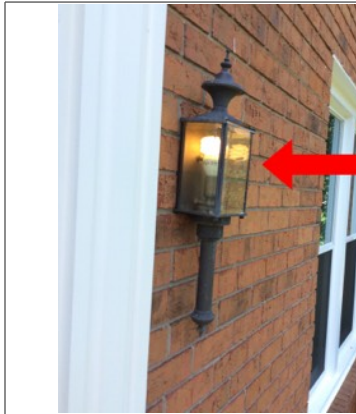
The exterior lights by the front door are loose. Secure the lights to the electrical box.

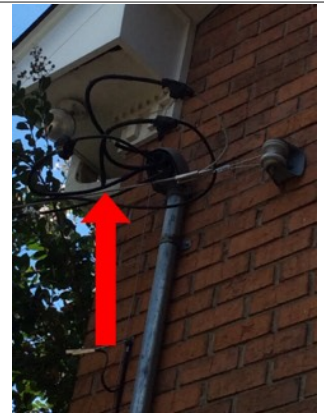
Deterioration was seen on the outer casing of the main electrical wires by the mast. Recommend having the wires evaluated and repaired if needed.

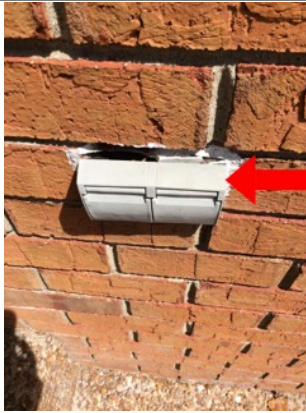
The rear exterior outlet is loose. Secure the outlet and cover to the electrical box.

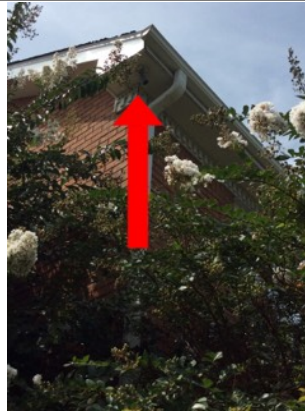
The exterior flood lights have no light bulbs. Add bulbs and test.

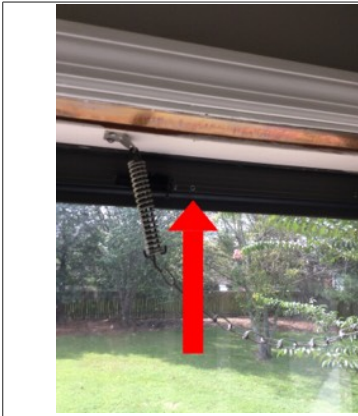
The automatic closure is missing on the rear storm door. Add an automatic closure for proper function.

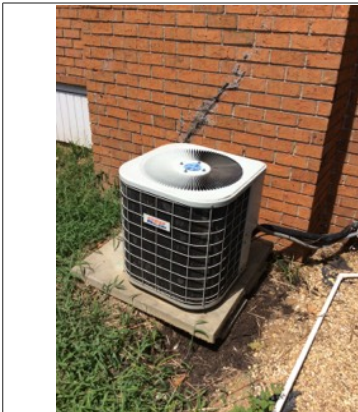
Second Floor Condenser Unit

Comments The exterior condenser unit for the second floor heating and cooling system is 18 years old. The unit is in working order but may need repairs or replacement in the near future.

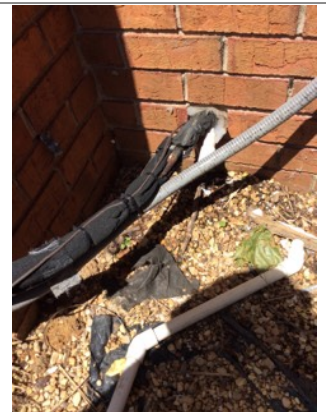
The insulation for the exterior AC coolant lines is damaged. Replace the insulation for maximum system efficiency.

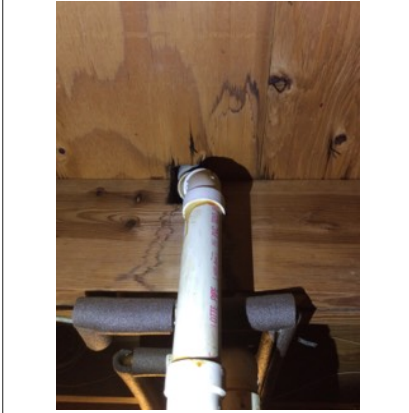
Moisture stains were seen on the floor sheathing in the garage around the washer drain pipe.

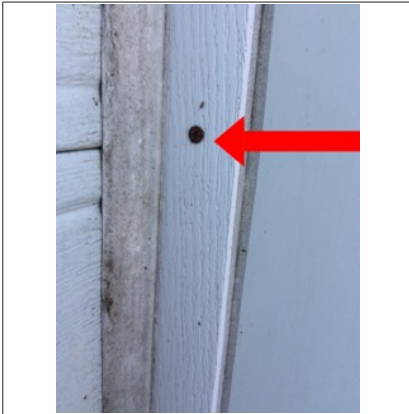
Sheetrock screws were used to hold the weatherstrip around the garage overhead door opening in place. The screws are rusting. Recommend replacing the screws with non rusting fasteners.

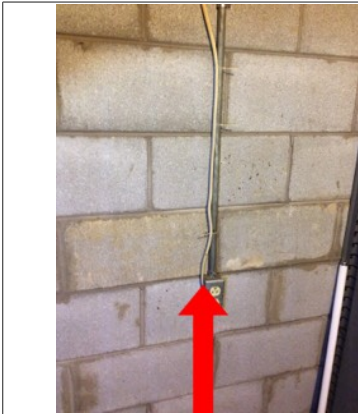
Protective conduit is recommended for the electrical wires leading to the electrical outlets in the garage.

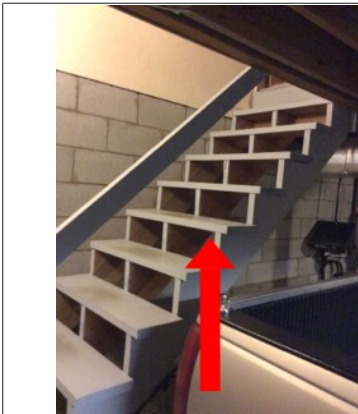
Recommend adding spindles to the garage stairs for added safety.

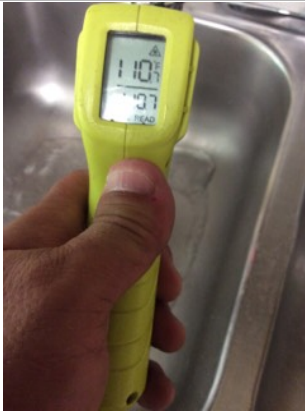
The hot water temperature at the kitchen sink is 110 degrees.

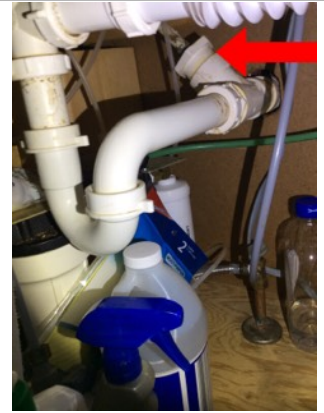
The dishwasher drain pipe has been installed on the back side of the trap. Sewer gases may enter the dishwasher due to the installation. Recommend having the drain pipe installed on the top side of the trap.

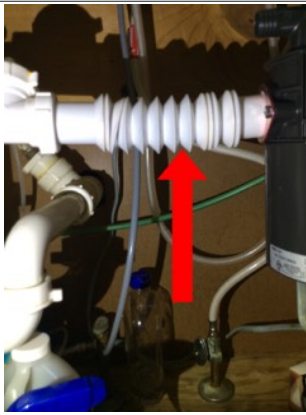
A flex pipe was used in the plumbing under the kitchen sink. Add a straight pipe for better drainage.

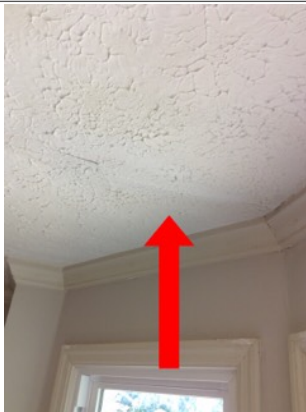
Moisture stains and sagging were seen in the ceiling of the eat in kitchen. Repair the ceiling.

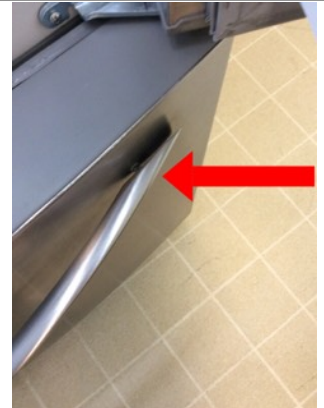
The freezer door handle is loose. Repair the handle.

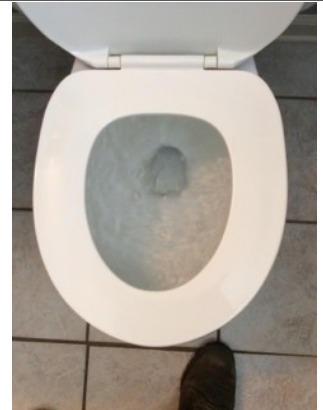
The toilet in the half bathroom is loose. Secure the toilet to the floor. The toilet also flushes slowly.

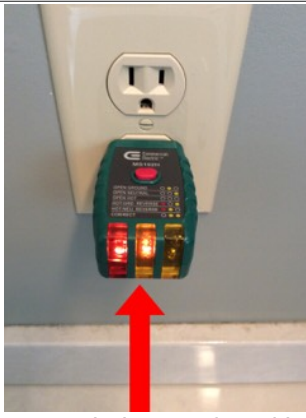
Reverse polarity was found in the electrical outlet in the half bathroom. Repair the outlet.

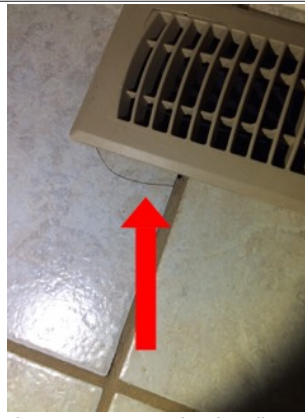
Cracks were seen in the floor of the half bathroom. Repair.

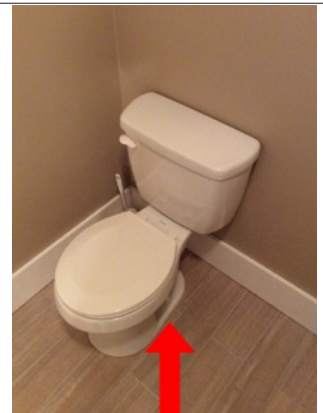
The toilet in the second floor hallway bathroom is loose. Secure the toilet to the floor.

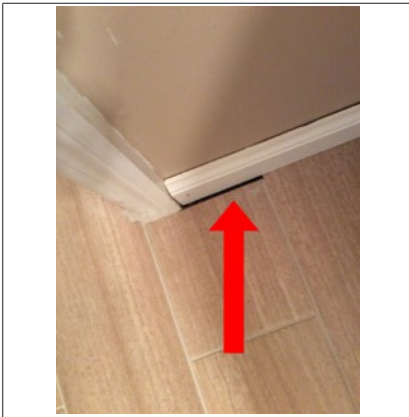
A few gaps were seen on the side of the tile floor in the second floor hallway bathroom. Seal the affected areas.

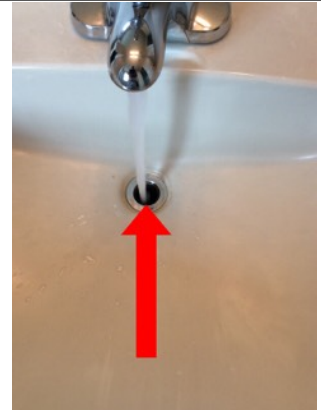
The stopper for the master bathroom sink is missing. Add a stopper to the sink.

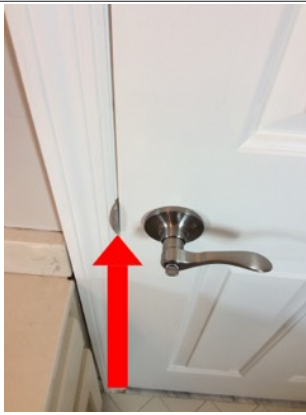
The master bathroom door rubs slightly on the door frame. Adjust the door or hardware for proper function.

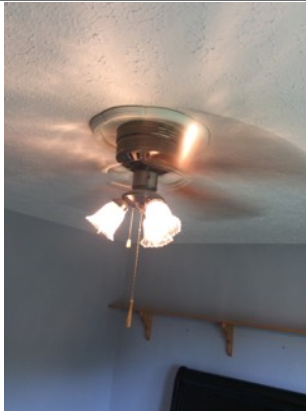
The ceiling fan in the Northeast bedroom is noisy.

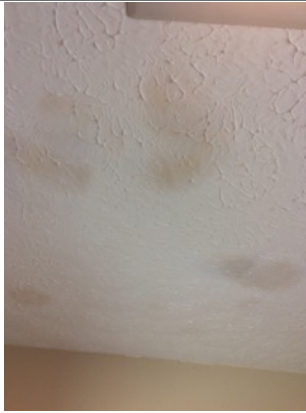
Moisture stains were seen on the ceiling of the bonus room.

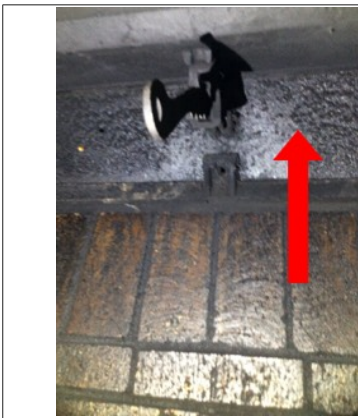
Recommend having the chimney and fireplace cleaned and examined before it's next use.

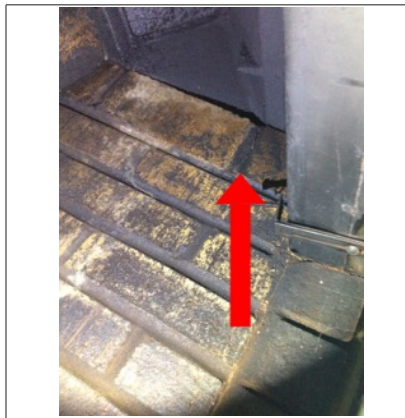
A few small cracks were seen in the brick of the fireplace. Repair the cracks.

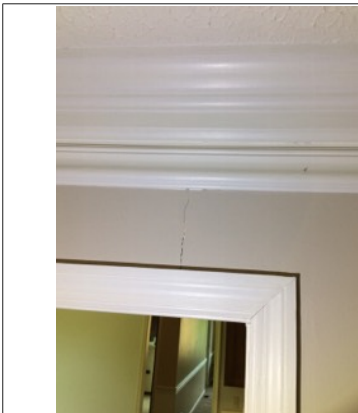
Small crack.

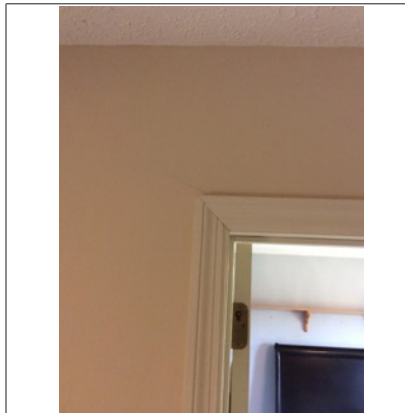
Small crack.

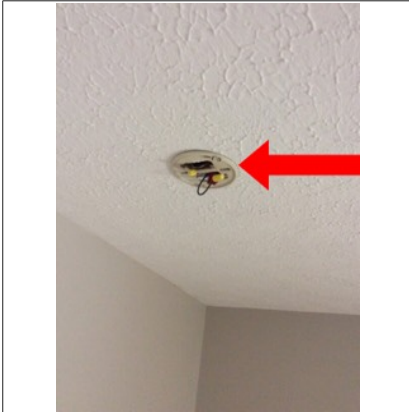
The wired smoke detector at the top of the stairs is missing. Add a new wired smoke detector.

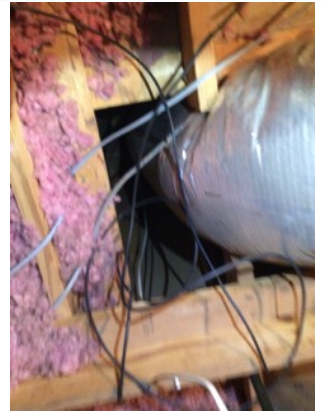
Missing insulation

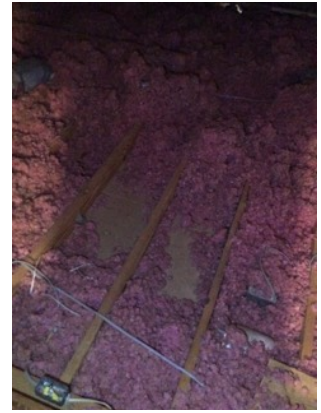
Missing insulation

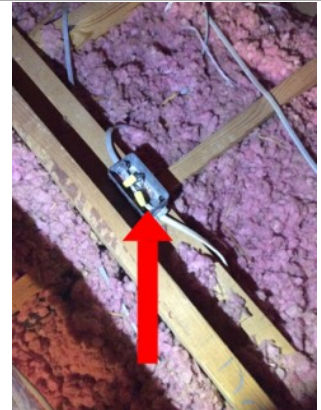
An open electrical junction box was seen in the attic. Add a cover to the junction box.

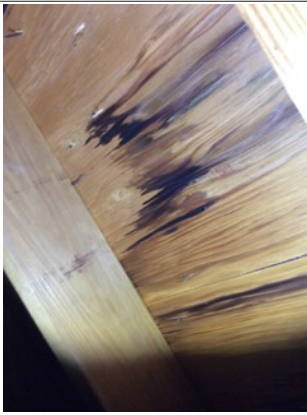
Staining on the roof sheathing.

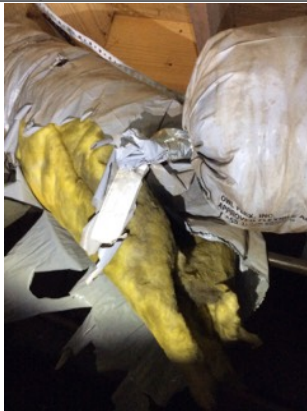
A disconnected HVAC duct was found in the crawlspace. Repair the duct.

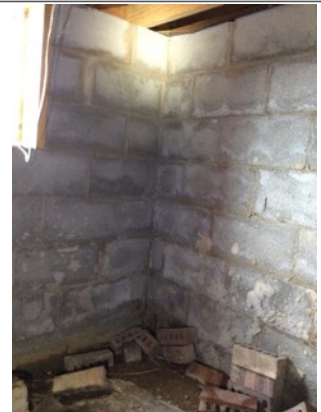
Moisture stains and effervescence was seen on some of the foundation walls.

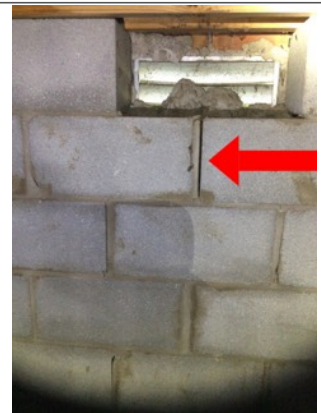
Small cracks were seen along the front wall of the crawlspace. Seal/repair the affected areas.

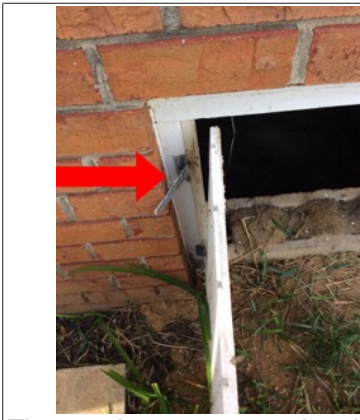
The crawlspace access door is damaged. Repair or replace the door.

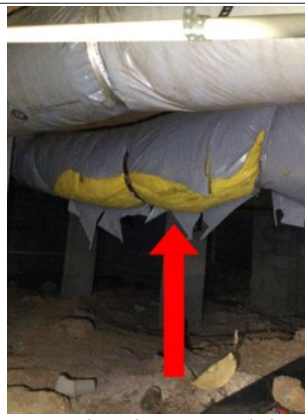
The vapor barrier around the crawlspace HVAC ducts is damaged. Repair the ducts.

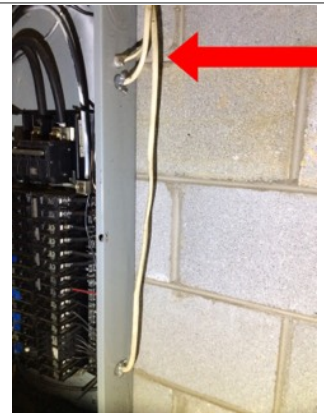
Recommend enclosing any reachable wires that are leading to the main electrical panel in protective conduit for added safety.
