Home Inspection Report

PROFESSIONAL HOME INSPECTION

Anywhere Road , Nashville , TN 37216

Friday, June 29, 2018

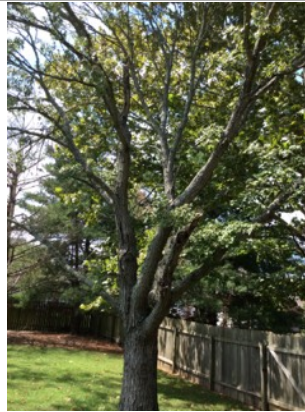
Dead limbs were seen on a few of the trees in the back yard. Remove the the unhealthy trees.

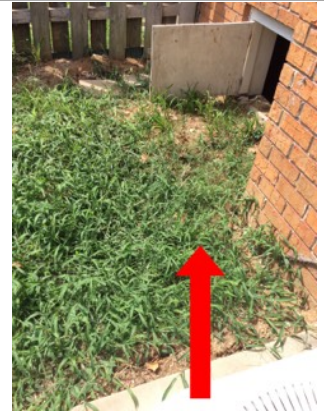
A few low spots were seen in the ground by the crawlspace access door. Add backfill to the area to ensure proper drainage away from the house.

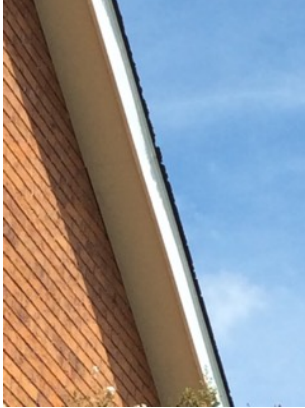
The shingles on the edge of the south side of the roof are damaged. Repair.

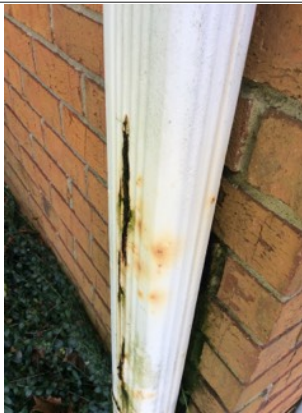
Damaged downspout

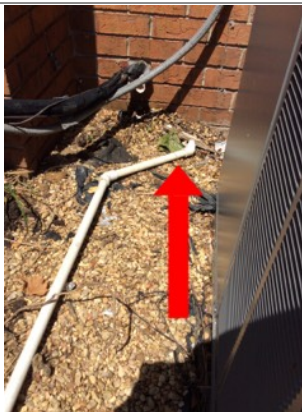
The exterior condensation drain extension for the AC unit has become detached. Reattach the line to ensure proper drainage away from the house.

7. The exterior condensation drain extension for the AC unit has become detached. Reattach the line to ensure proper drainage away from the house.
8. A small hole was found in the vent at the front side of the house. Repair/replace the vent.

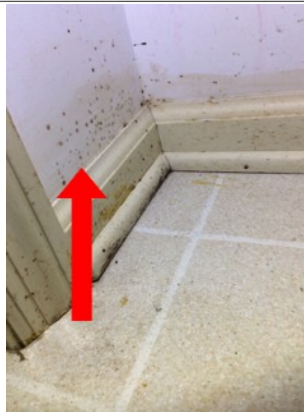
Indications of fungal growth were found in the kitchen pantry. Recommend having the fungal growth removed.

5. Indications of fungal growth were found in the kitchen pantry. Recommend having the fungal growth removed.
6. Reverse polarity was found in the electrical outlet in the half bathroom. Repair the outlet.

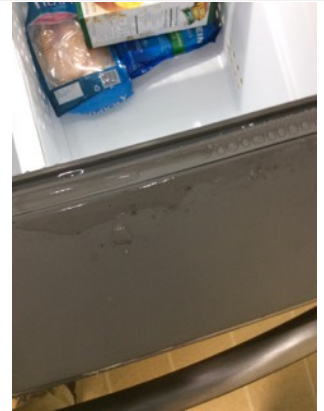
Water was seen on the freezer door.

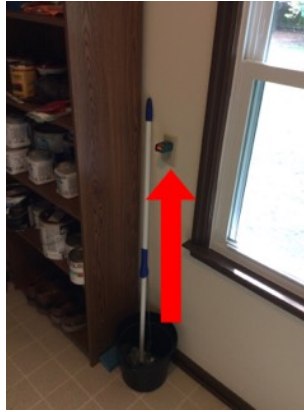
An outlet in the laundry room is loose. Secure the outlet to the electrical box.

19. The freezer door handle is loose. Repair the handle.
20. An outlet in the laundry room is loose. Secure the outlet to the electrical box.
21. Cracks were seen in the floor of the half bathroom. Repair.

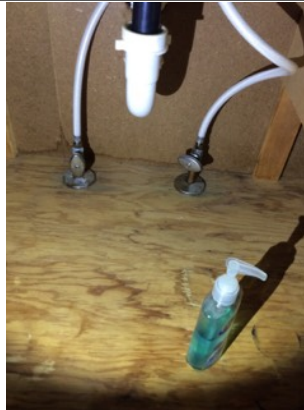
Moisture stains were seen on the base of the vanity in the half bathroom.

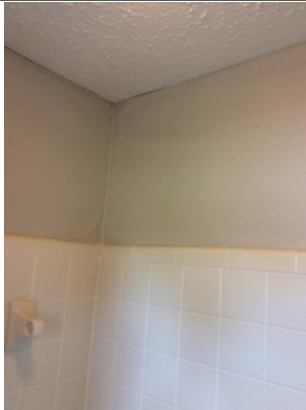
The wallpaper around the master bathroom surround has wrinkled. Repair or replace the wallpaper.

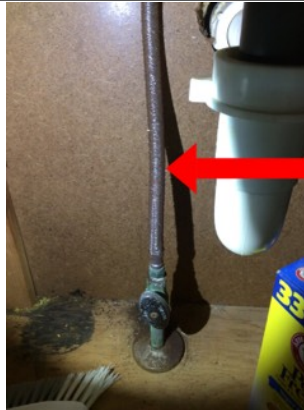
The water line under the master bathroom sink has rusted. Replace the line to help prevent future leaking.

24. A few gaps were seen on the side of the tile floor in the second floor hallway bathroom. Seal the affected areas.
25. The water line under the master bathroom sink has rusted. Replace the line to help prevent future leaking.

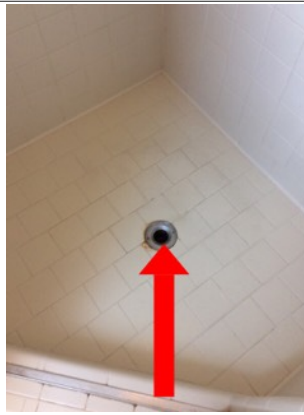
The drain protector in the master bathroom shower is not installed. Install the hardware.

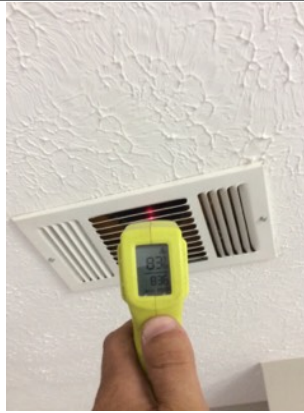
One of the ducts for the master bedroom has been disconnected.

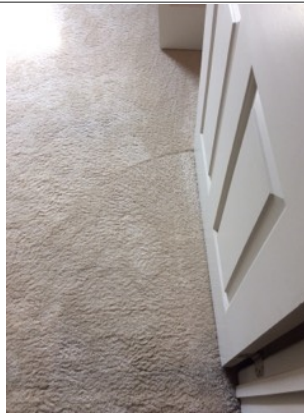
The west bedroom door is rubbing on the floor.

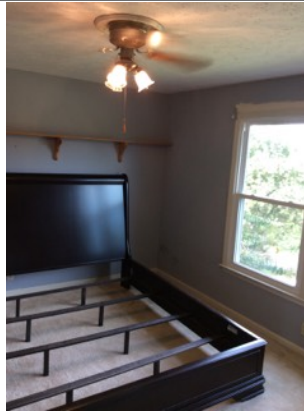
Northeast Bedroom

The ceiling fan in the Northeast bedroom is noisy.

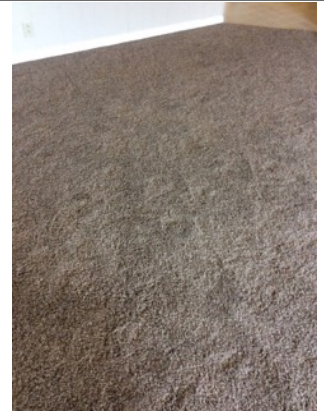
The floor in the bonus room squeaks and flexes when walked on. Some of the nails in the subfloor did not hit the floor joists causing the subfloor to flex. Secure the subfloor to the floor joists. Additional bridging or strapping may also be needed to help with the floor flexing.

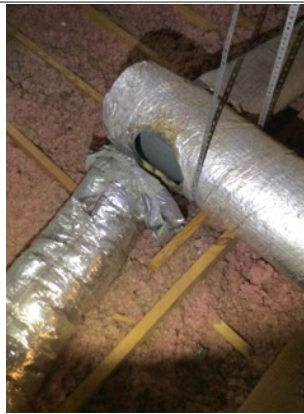
An HVAC duct has been disconnected from the main trunk duct in the attic. Reattach the duct. Different sized ducts were also seen in the attic. Recommend having a licensed HVAC evaluate the HVAC system.

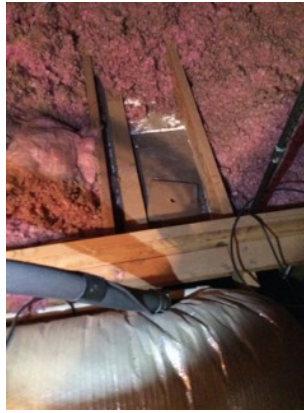
Missing insulation

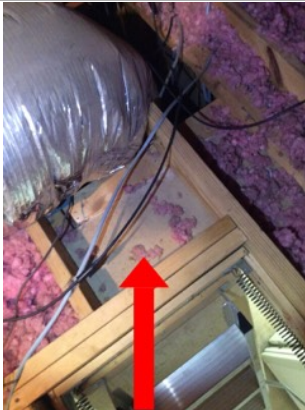
Insulation is missing in multiple areas in the attic. The insulation base varies from 2-6 inches deal. Recommend adding additional insulation to the attic.

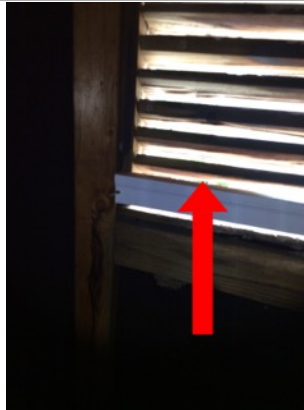
A screen is missing on the south side gable vent. Add a screen to the vent.

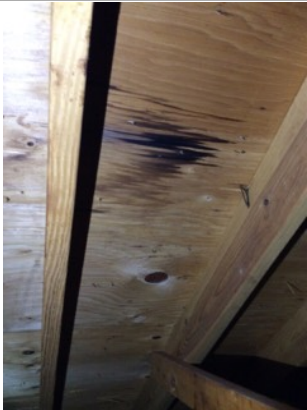
Moisture stains were seen on the roof sheathing.

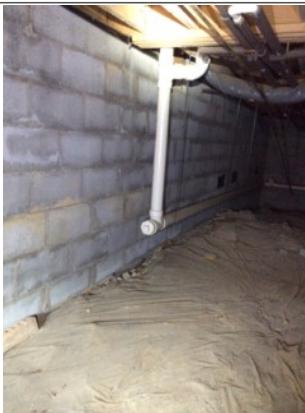
Crawlspace

Moisture stains and effervescence was seen on some of the foundation walls.

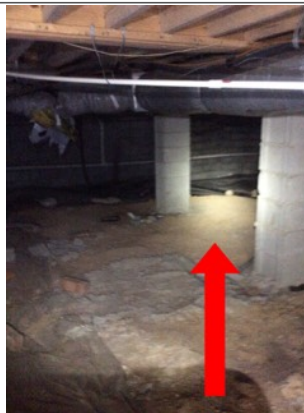
A vapor barrier is missing in parts of the crawlspace. Add a vapor barrier to the affected areas.

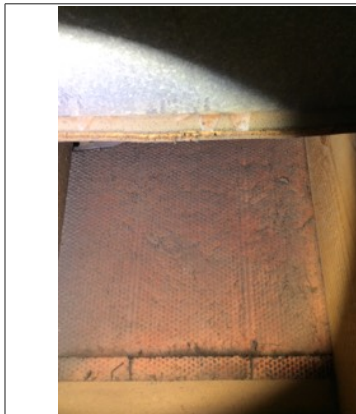
Air return

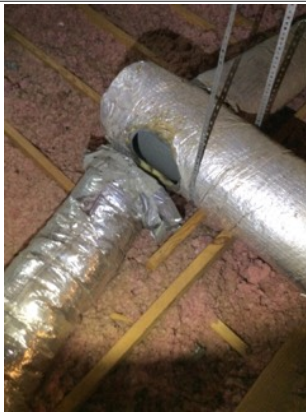
Disconnected duct

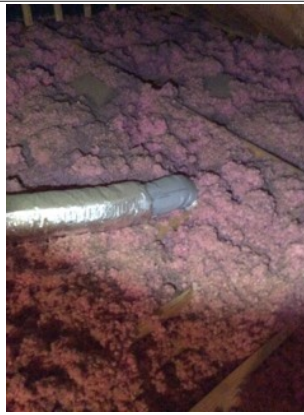
Different sized ducts.
